**CONSTRAINTS OF HABITAT AND
CHANNEL STABILITY ON THE DEVELOPMENT OF
DRAINAGE IMPROVEMENT ALTERNATIVES FOR THE
S-1 TO S-3 AND N-1 TO N-5 URBAN PLANNING ZONES**

**Prepared for:
Olsson Associates
1111 Lincoln Mall
Lincoln, Nebraska 68501**

**Prepared by:
Wright Water Engineers, Inc.
2490 W. 26th Ave., Suite 100A
Denver, Colorado 80211
And Edwin Herricks, Ph.D.**

January 2001

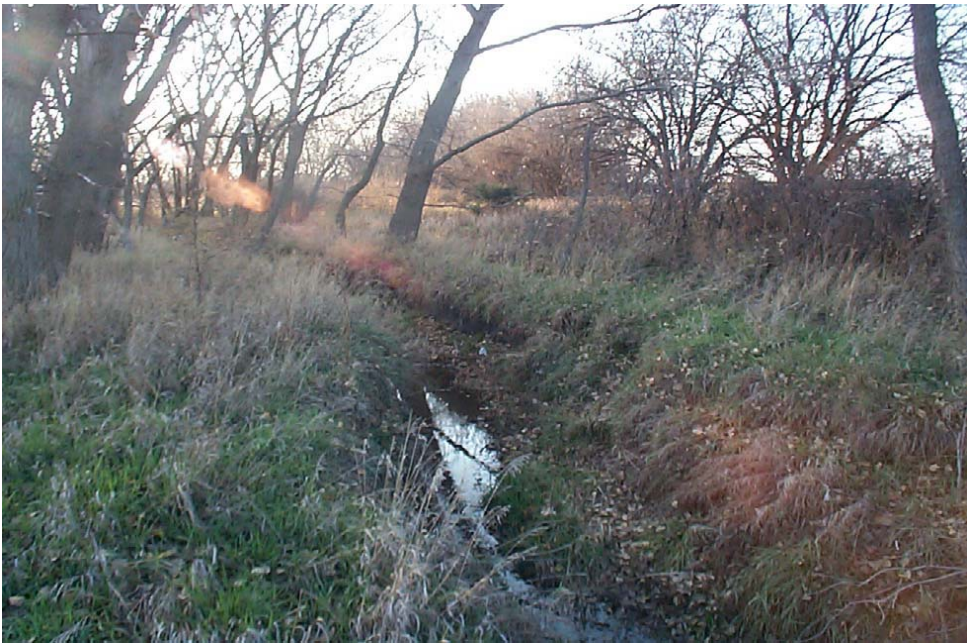
Catchment S-2 consists mostly of agricultural development except for the golf course on the northern edge of the catchment. The riparian area around the channels has been preserved in some areas. This includes native trees and shrubs within a buffer zone around the drainageway. Photograph 1 shows the area immediately downstream of 40th Avenue. In other areas, grading for agricultural development has taken place up to the edge of the low-flow channel of the drainageway. There is no riparian vegetation in these areas. Photograph 2 shows the area immediately upstream of 40th Avenue.

Photograph 1. Stream channel immediately downstream of 40th Street in the S-2 catchment. A riparian buffer has been preserved.

2. **Catchment S-2.** This catchment lies downstream of catchment S-3 but will not be significantly affected by that catchment, unless widespread land use changes occur in the future, because S-3 is mostly built out with low-density residential development. The stream channel between 27th and 40th Streets currently shows mild degradation in some areas. The degradation of the channel will increase with development of the S-2 catchment. The channel should be monitored to determine whether it is degrading due to

development in the watershed. The channel should be stabilized with bed stabilization measures when the monitoring shows that problems are developing. A buffer area adjacent to the channel should be maintained, enlarged or provided, depending on the current condition of the riparian area.

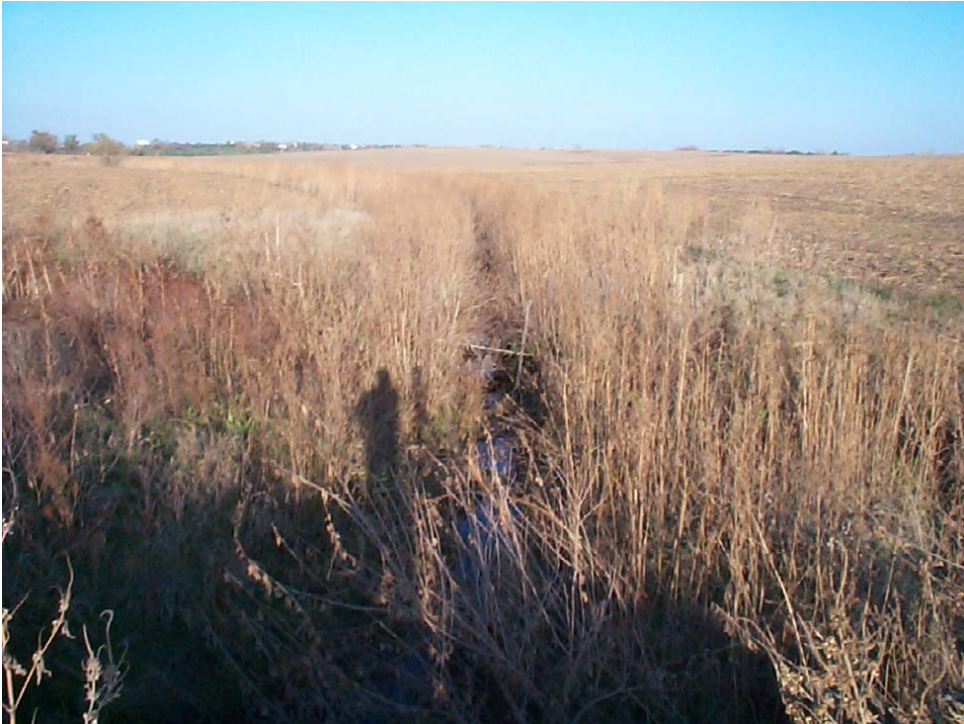
Photograph 2. Stream channel immediately upstream of 40th Street in the S-2 catchment. Riparian vegetation has been removed for agricultural development.

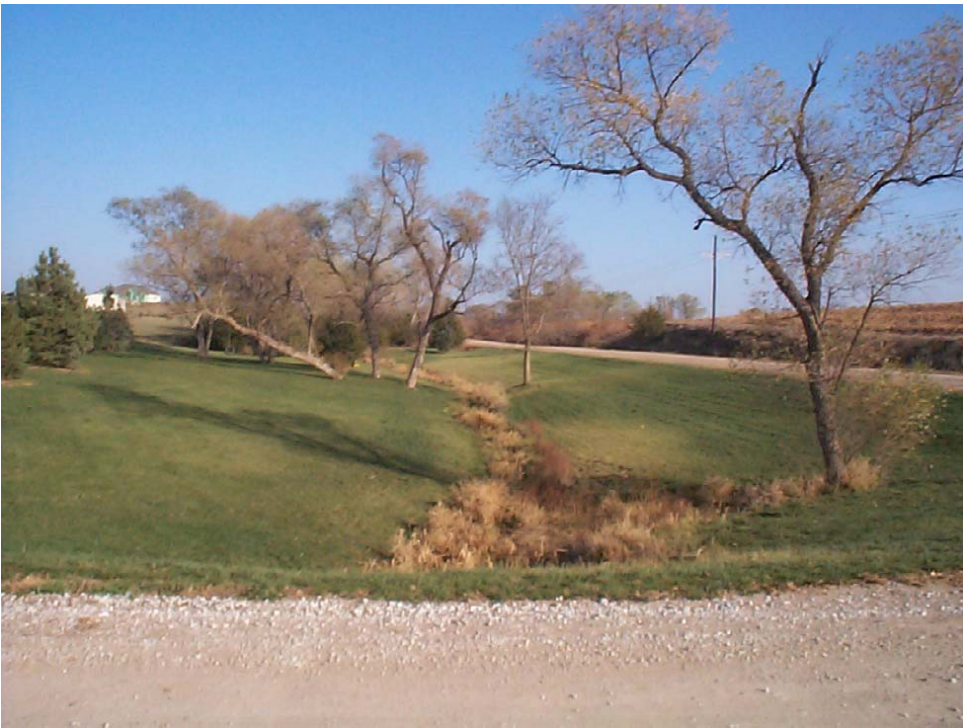
The channels in the S-3 watershed show little degradation in the reaches upstream of 40th Street. There is increased degradation, as shown by vertical channel incision in the lower portions of the

S-2 watershed. There was no flowing water in any of the channels at the time of the September or October 2000 site visits. There was a small area with standing water.

Photograph 3. Drainageway in Catchment S-3 adjacent to Rokeby Road.

3. **Catchment S-3.** This catchment is largely developed. Detention should be provided in areas that will undergo future development. Consideration should be given to retrofitting storage in the existing developments. Hydrologic analyses should be carried out to determine whether retrofitting storage facilities will produce downstream benefits. The channels in this catchment appear to be largely in good condition and may not need stabilization measures.

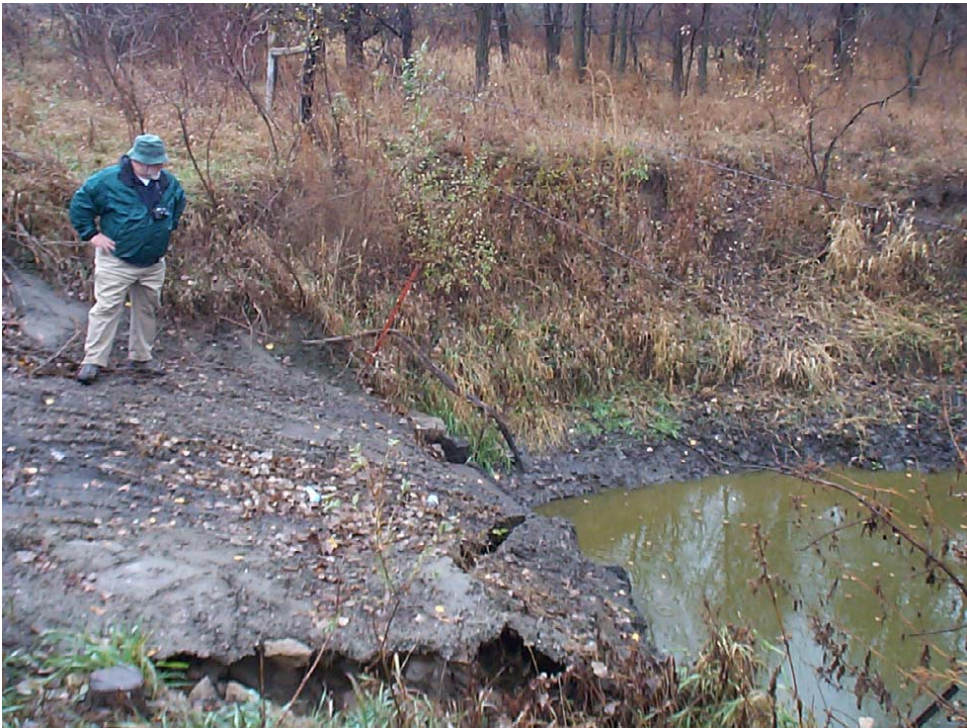
Many of the stream channels in the N-watershed show moderate to severe degradation. The degradation is manifested as vertical incision of the channels and accompanying sloughing of the

channel banks. In many cases, the degradation appears to be due to historic stream channelization or placement of culverts.

The N-2, N-3 and N-5 catchments have agricultural development. The channels in these catchments show head cutting and vertical incision. (See photographs 4 and 5.) Catchment N-4 does not show channel incision but has deposition in some areas.

Photograph 4. Channel with head cutting or scour hole downstream of channel.

5. **Catchments N-2, N-3 and N-5.** These catchments are all dominated by agricultural development. The creek channels in these catchments show moderate to serious degradation. Little Salt Creek through this area has degraded because of historic channelization of the channel in the reach upstream of Interstate 80 and down cutting to match Salt Creek's channel. This section of channel is straight and deep with steep, unstable banks. North of Bluff Street, the channel is more natural and less degraded. The tributaries in these catchments show incision that is progressing upstream from Little Salt Creek or, in some instances, is progressing upstream from culverts placed at too low elevations. Channel bed stabilization is essential for these catchments. Little Salt Creek may be at or near a stable slope and, consequently, not need stabilization. The resulting

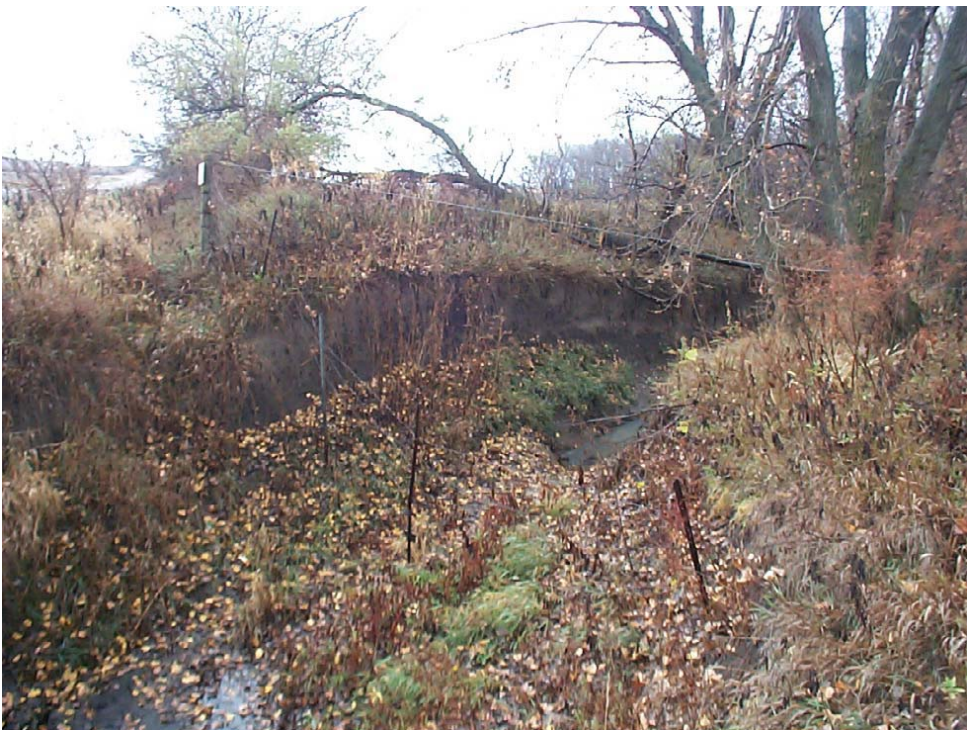
Photograph 5. Channel with vertical incision.
